NEW SOUTH WALES FIRE BRIGADES

OPERATIONS BULLETIN 2003/5

Maintenance of positive pressure ventilation (PPV) fans.

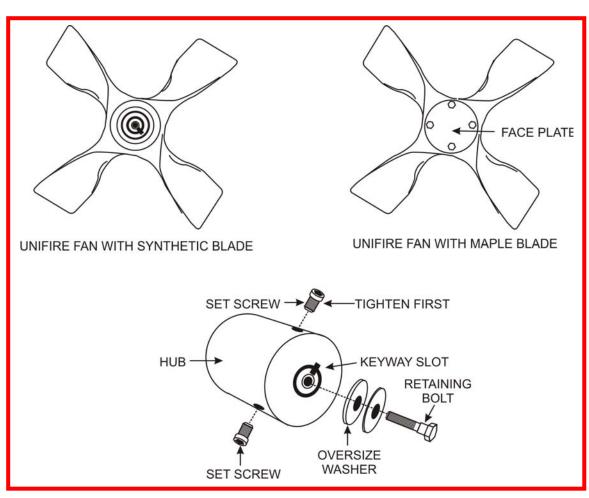
Figure 1 Unifire Fans.

- The Unifire hub is a one piece assembly. The hub is attached to the crankshaft by two set screws and one bolt.
- Annually remove the two set screws and bolt, and check the hub for damage.

- For units with the older Maple laminated blades, the four bolts and face plate that secure the blade onto the hub should be removed to allow access to the crankshaft bolt.

- Reassemble the hub as follows:
- Place loctite 260 or higher on threads of the set screws and a drop in the hole on the hub. Second tighten the screw with the keyway slot first. Next tighten the set screw on opposite side of key way. Torque set the set screws to 24in lbs.

- ➤ The next step is to place the 5/16" x 24 x 1 1/4" and 5/16" washer and an oversized washer provided (in some older units their may be two over sized washers) and place loctite 260 or higher on the bolt and insert into the front of the hub and thread into the end of crank shaft (torque to 12ft lbs).

- ➤ For units with the older Maple laminated blades, bolts holding the blades and face plate should be torqued to 12ft lbs. Remember to use lock washers and loctite along with nyloc nuts. Tighten bolts in a cross pattern.

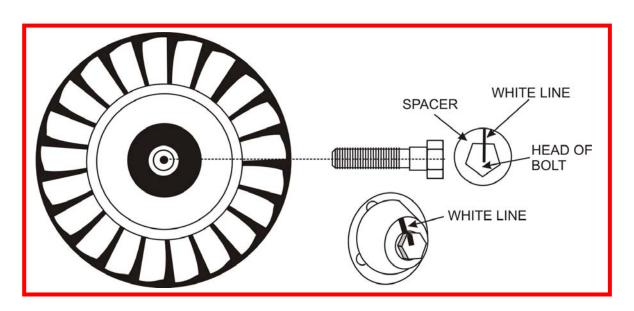
Figure 2 Ramfan.

- 1. Remove shroud guard.
- 2. Clean fan with a soft cloth and warm soapy water.
- 3. Visually inspect fan for damage.
- 4. Check the white marking on the bolt head and spacer for correct alignment (refer to figure).
- 5. Should the white marking be incorrectly aligned, take the fan to a local mechanical workshop and have the above procedure carried out.
- 6. If the white marking is correctly aligned, replace guard and ensure that all screws have loctite applied to the threads.

- 1. Remove shroud guard.
- 2. Unscrew the centre bolt and remove any white mark from the spacer and bolt.
- 3. Ensure the spacer is kept and replaced.
- 4. Clean the thread on the bolt.
- 5. Apply loctite 410 or similar to the bolt thread.
- 6. Ensure the spacer is in place and replace bolt.
- 7. Tighten with torque wrench to 27Nm.
- 8. Apply a white mark that runs in a straight line across the head of the bolt and onto the spacer (as shown in figure).
- 9. Ensure that all foreign matter is removed from the fan shroud and guard.
- 10. Replace guard and ensure that all screws have loctite applied to the threads.
