New South Wales Fire Brigades Operations Bulletin 2008/08 Automatic Teller Machine Gas Attacks

Issue

There have been a number of recent incidents in Australia and overseas where Automatic Teller Machines (ATMs) have been severely damaged when explosive gasses are used in attempts to steal the cash contents. This bulletin was developed with the NSW Police Force to warn NSWFB personnel of the dangers involved and to outline appropriate actions when attending ATM incidents.

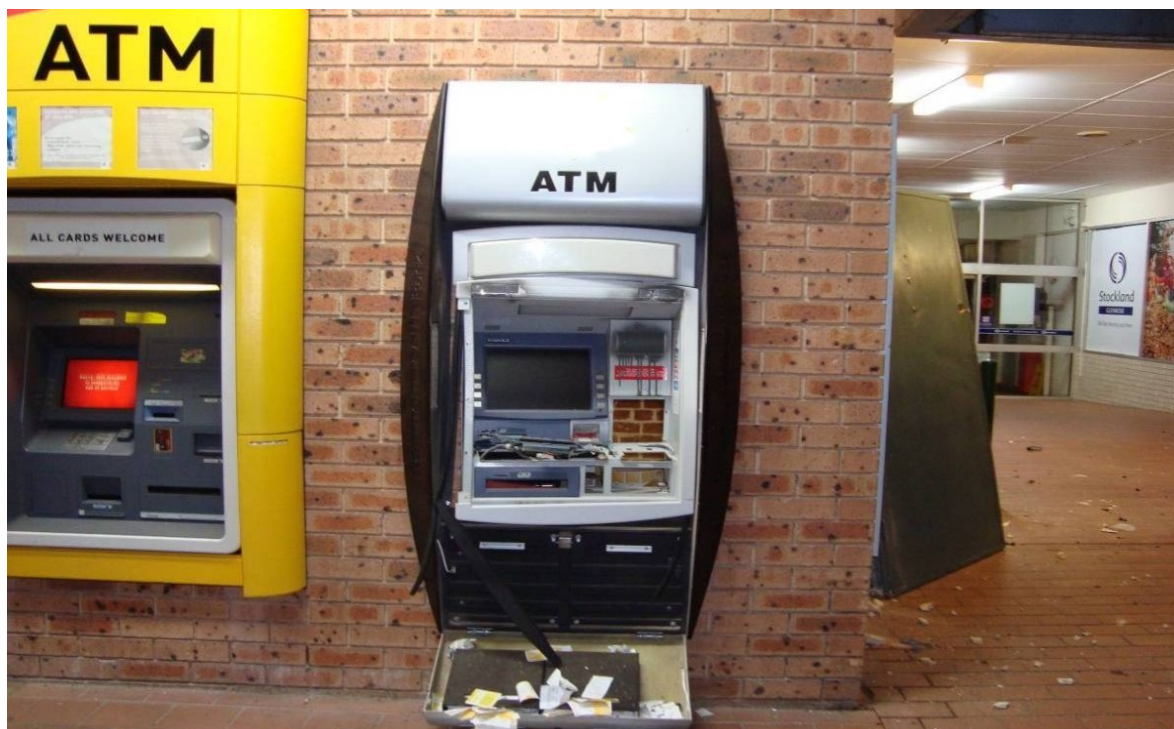
Figure 1 ATM in wall damaged by explosion

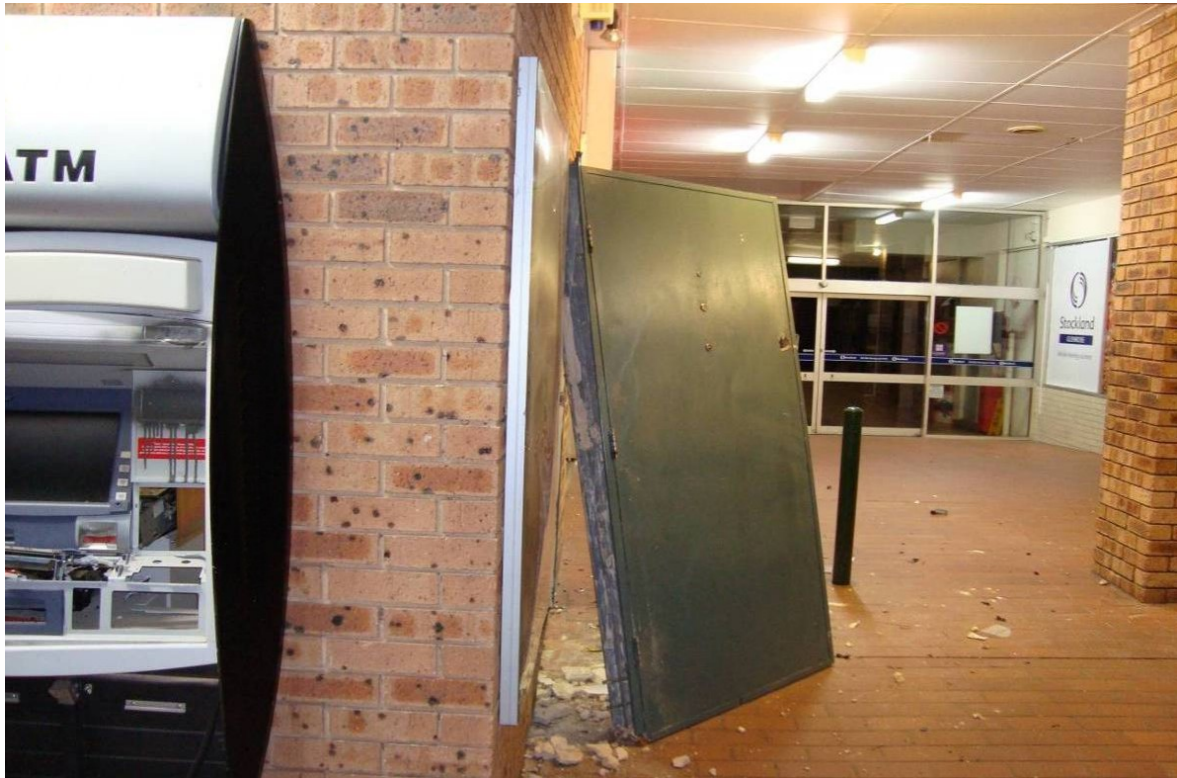
Figure 2 Door blown off hinges by force of explosion shown in Figure 1

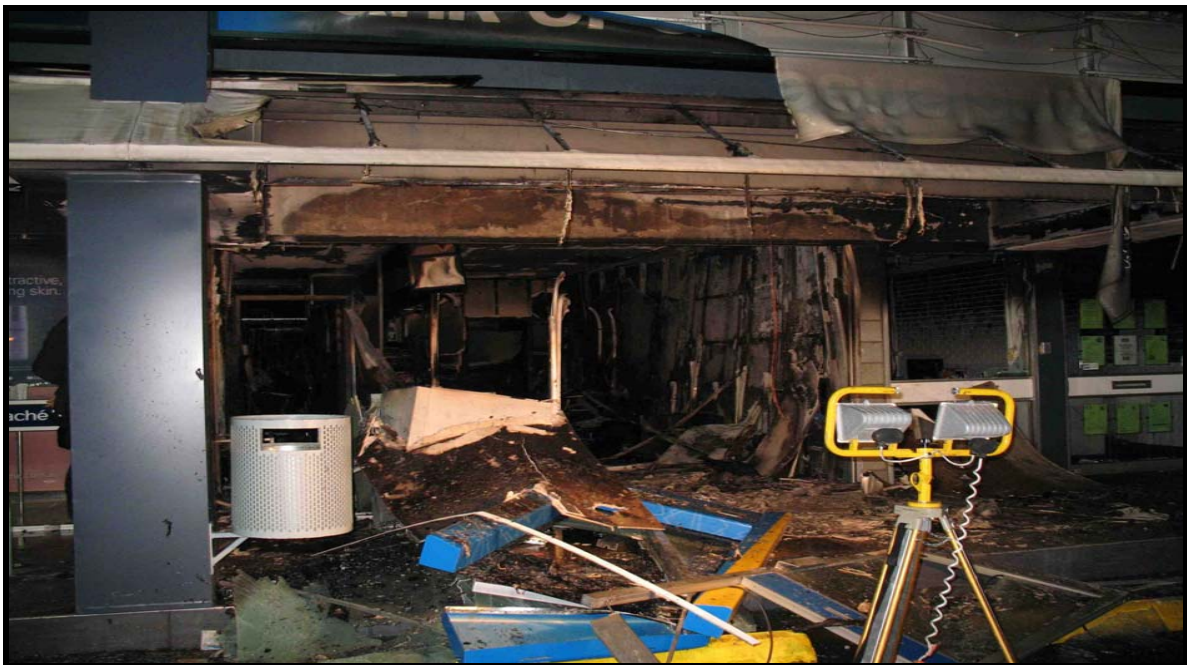
Figure 3 Shop front destroyed and awning damaged by force of explosion

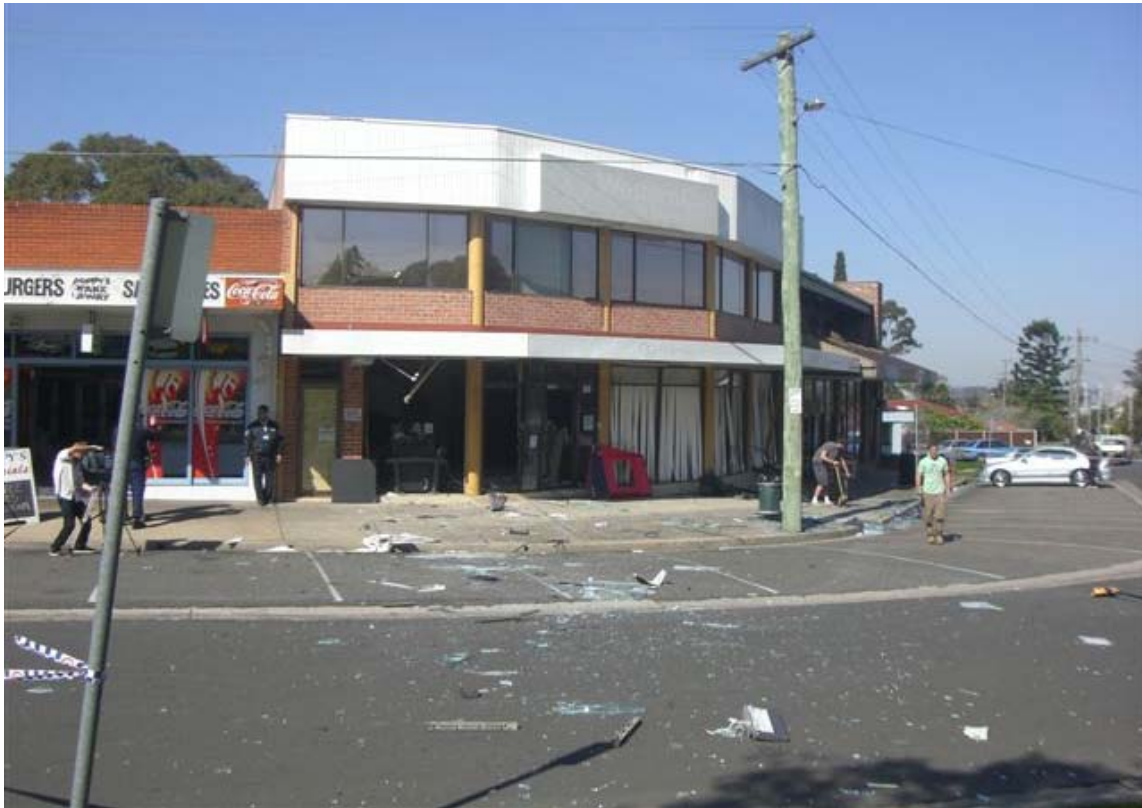
Figure 4 Shopfront destroyed by force of explosion

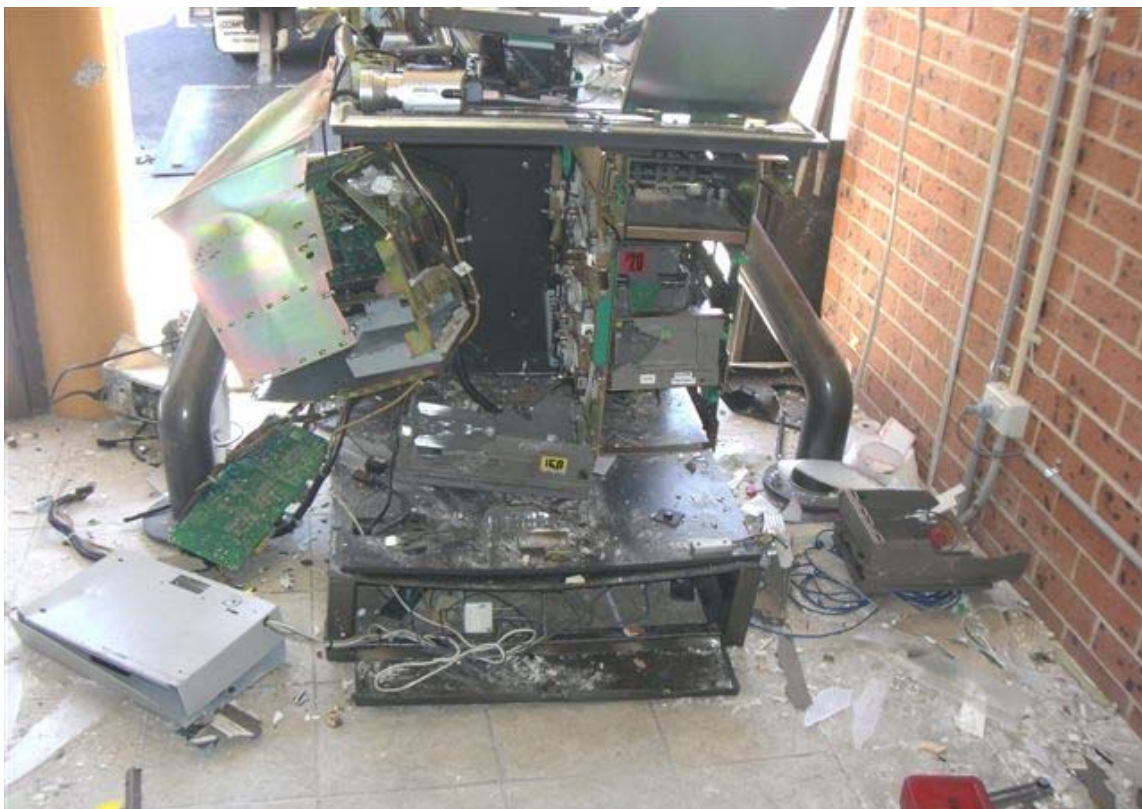
Figure 5 ATM destroyed by the explosion shown in Figure 4

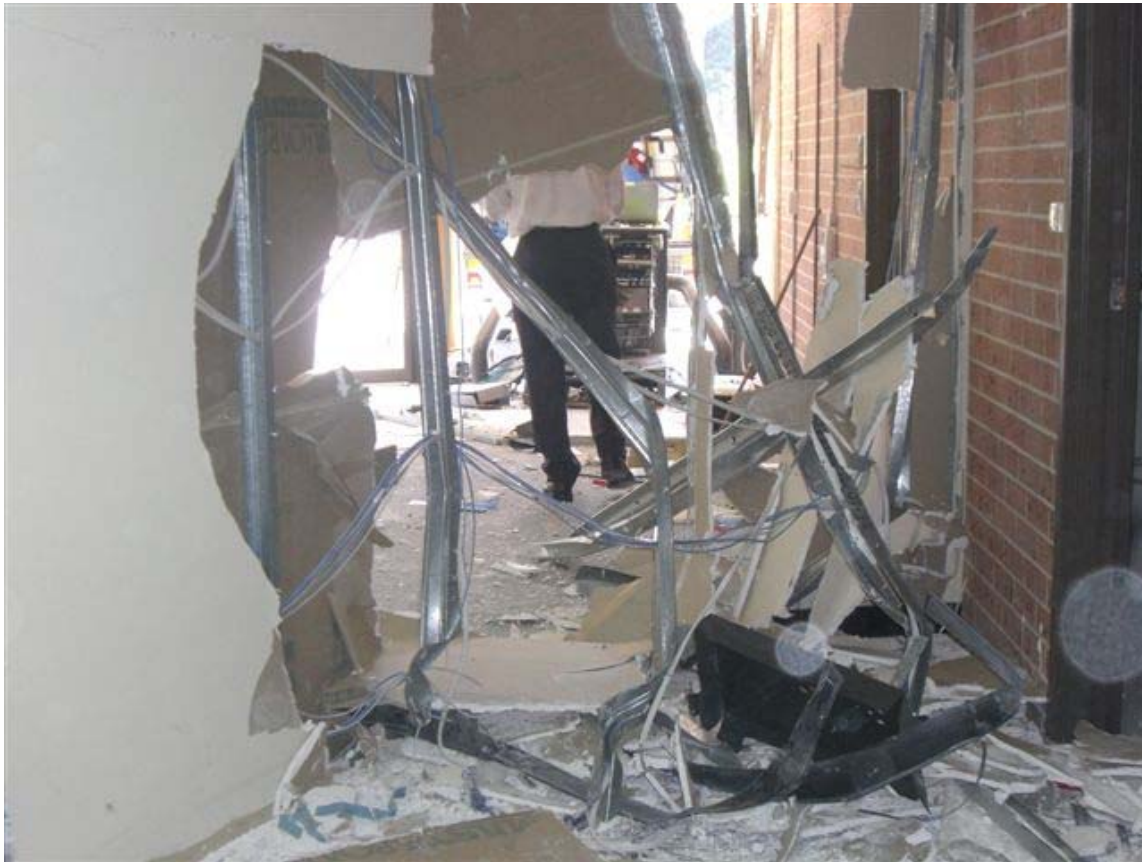
Figure 6 Internal partition wall 20 metres from the ATM destroyed when the back was blown off the ATM by the explosion shown in Figure 4
