# New South Wales Fire Brigades Safety Bulletin 2010/01 Dangerous tyre conditions

# Safety Bulletin 2010/01

## Dangerous tyre conditions

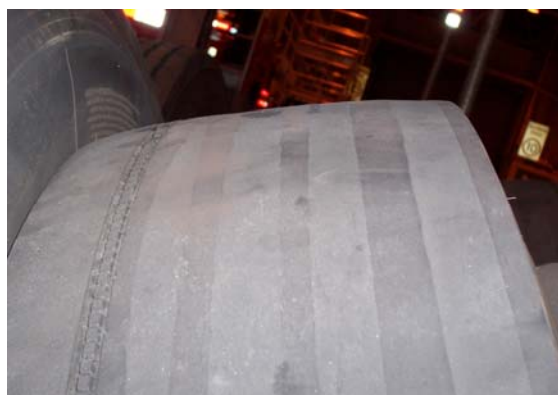
**Excessively worn tyre**

- All drivers must ensure that their appliance is immediately checked in accordance with In Orders 2008/12 and the relevant SIMS Appliance Worksheet.
- Station Commanders must immediately ensure that all appliances have been checked and any non-compliant tyres have been reported to the Fleet Management Unit. Station Commanders should also ensure ongoing compliance with the In Orders 2008/12.
- Duty and Zone Commanders, when visiting stations over the next three months, must ensure that visual inspection of appliance tyres has occurred in accordance with NSWFB policy as this is a critical safety issue.

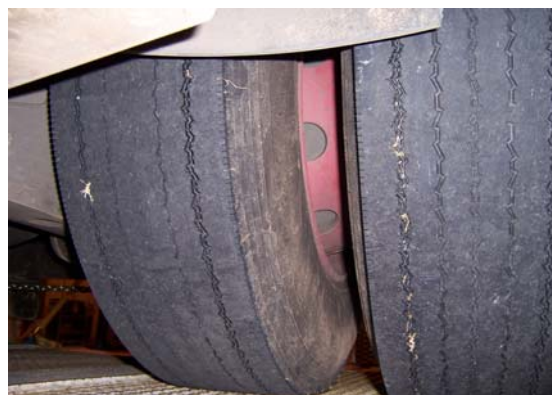
**Uneven tyre wear**
